PROJECT MONITORING COMMITTEE
INSPECTION REPORT

Project Details					
Project Title	Construction of Drainage System at Zone V in Ayala				
Contract Amount	Php 2,987,666.54	Budget Year	AB FY 2022	Amount Collected	Php 2,541,947.76
NTP Date	July 23, 2023	Target Date of Completion/Revised end Contract	September 7, 2023/November 7, 2023	Target Duration	64 Days/108 days
Acceptance Date	N/A	Actual Date of Completion	November 16, 2023	Actual Duration	117 days
Reported Status	Ongoing	Inspection Status	Completed	Slippage	N/A
Contractor	ZAMBOANGA ERECTORS & CONTRACTORS INC.			Project Engineer	Engr. Michael Richie R. Manuel
Inspection Rating	Satisfactory			Inspection Date	March 19, 2024
Scope of Work:	Type: PLAN ____ Length N/A Width N/A Height		Type: Actual ____ Length N/A Width N/A Height		Spot Map:
Requirements:	<div><div><input checked="" type="checkbox"/> Billboard</div><div><input checked="" type="checkbox"/> Temporary Facility</div><div><input checked="" type="checkbox"/> Backhoe with Breaker</div><div><input checked="" type="checkbox"/> Concrete/Bagger Mixer</div><div><input checked="" type="checkbox"/> Concrete Vibrator</div><div><input type="checkbox"/> Certificate of Occupancy</div><

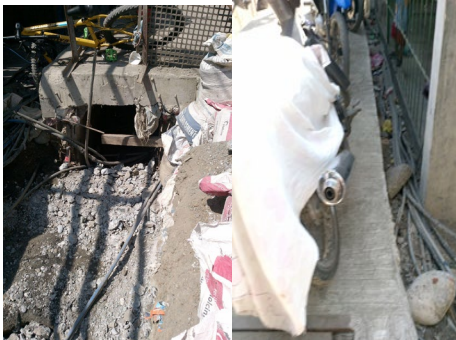
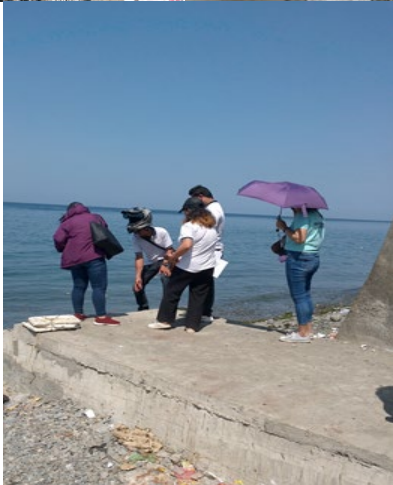
<div>Remarks:<p>The NTP was issued one year after the budget year. The project is completed, and its actual duration is 9 days longer than the plan. It was observed that there are water lines traversing inside the constructed drainage system, which is unsafe incase water contamination happens due to pipe leak. According to the Project Engineer, the seven (7) steel manholes were not in place, because this might cause danger to the residents when high tide occurs.</p></div> <div>Recommendation:<p>The project engineer is encourage to remind the contractor to submit necessary documents for final billing.</p></div>

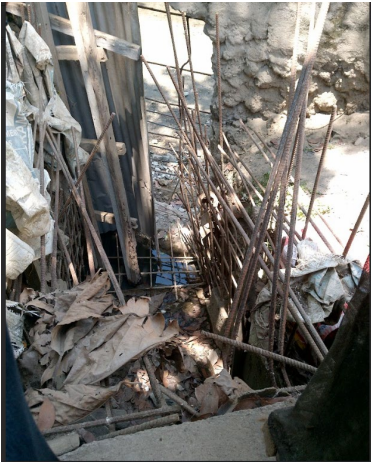
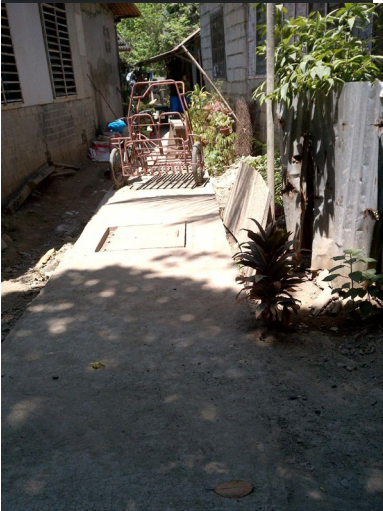
</div>
<div>Remarks:</div> <p>The NTP was issued two years after the budget year. The actual duration of the project is 8 days earlier than the plan. The project is completed however it was noted that the riprap wall was hollow/open to give way to the contracted drainage outfall. But the drainage outfall was left incomplete and this might cause damage to the riprap wall as well as the safety of the resident residing in the area. The contractor will be informed on this matter according to the PE. The contractor has collected 85.13% of the contract price as of April 3, 2023.</p> <div>Recommendation:</div> <p>The project engineer is encouraged to monitor the contractor if the said deficiency were taken action with.</p>

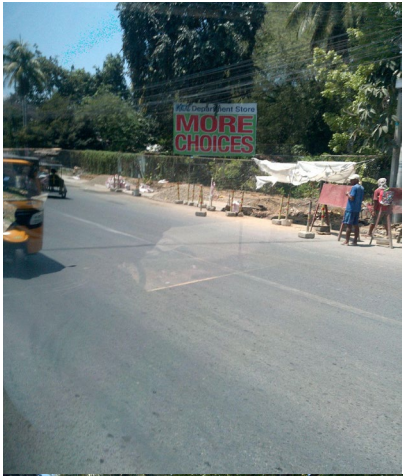
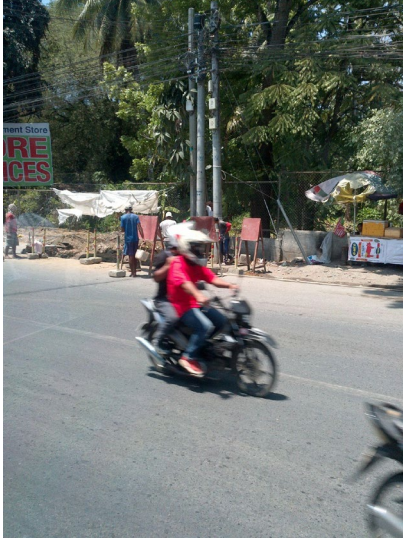
Requirements:	<u>✓</u> Billboard	<u>500</u> Skilled	
	<u>✓</u> Temporary Facility	<u>380-450</u> Unskilled	
	<u>✓</u> Backhoe with Breaker	<u>X</u> First Aid Kit	
	<u>✓</u> Bagger Mixer	<u>X</u> Hard Hat	
	<u>✓</u> Concrete Vibrator	<u>X</u> Safety Shoes	
	<u>N/A</u> Certificate of Occupancy	<u>X</u> Gloves	
	<u>N/A</u> Right-of-way/Setback Compliance	<u>N/A</u> PWD Ramp	
	<u>N/A</u> Engineer's Logbook	<u>N/A</u> PWD Grab Rails	
Remarks: The NTP was issued the same year of the budget year. About 90% of the project is already constructed and the contractor is in the process of conducting a schedule to connect/continue the construction of the cross drainage works at the national highway. The project incurred a negative 86.18% slippage due to Suspension order, requesting an excavation permit from DPWH. The contractor has collected 85.34% of the contract price as of April 12, 2024.

Recommendation: The project engineer is encouraged to monitor the status of the project since it is way behind schedule despite the revised date of completion.

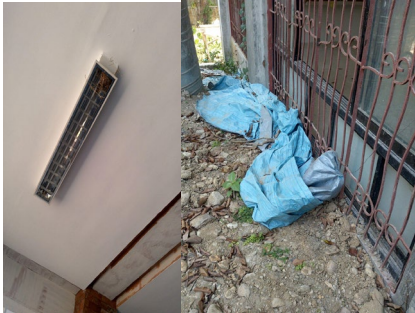
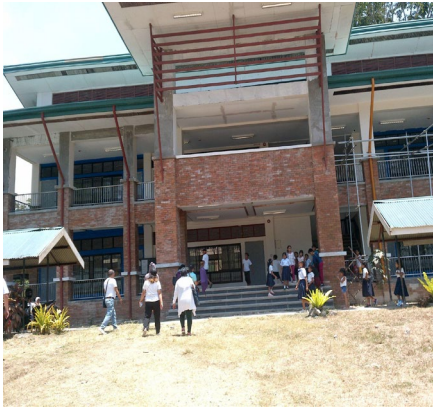
Remarks: The NTP was issued two years after the budget year. The project is ongoing and the component activities includes: painting, installation of septic tank, water tank, grills, blackboard and signage. It has been observed that the comfort room and lighting fixture are with birds' nests, stairs with damaged stair nosing, excavated filling materials embank a portion at the back of the building with window level. Concerns were addressed to the Project Engineer during the inspection. Recommendation: The project engineer is encouraged to monitor the working activities to fast track the completion of the project since it is way behind its schedule.

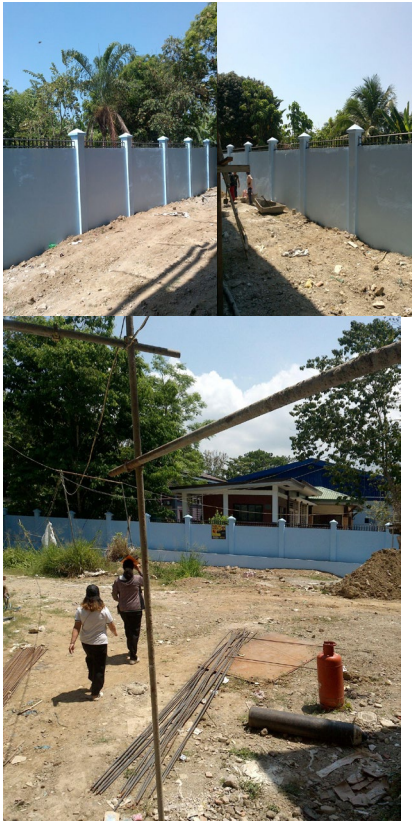
N/A Backhoe with Breaker	N/A First Aid Kit																				
N/A Bagger Mixer	N/A Hard Hat																				
N/A Concrete Vibrator	N/A Safety Shoes																				
N/A Certificate of Occupancy	N/A Gloves																				
N/A Right-of-way/Setback Compliance	N/A PWD Ramp																				
X Engineer's Logbook	N/A PWD Grab Rails																				
Remarks:																					
The NTP was issued the same year of the budget year. The project is completed with no major deficiencies noted. The contractor has collected 15% of the contract price as of November 13, 2023.																					
Recommendation:																					
For the project engineer to remind the contractor to submit the necessary requirements for final billing.
